## SUCCESS STORY

### - Mechanical Refurbishment of Herkules Roll Grinder and - Naxos Roll Grinder – Posco Thainox - Thailand

#### Description of Project 60480:

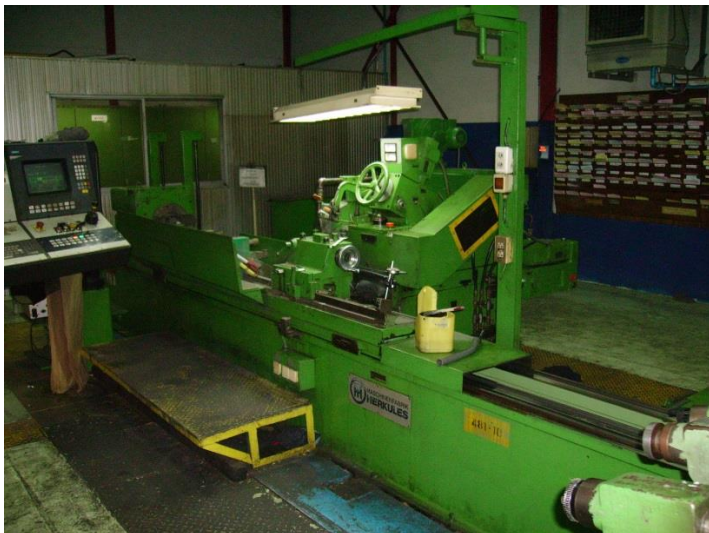
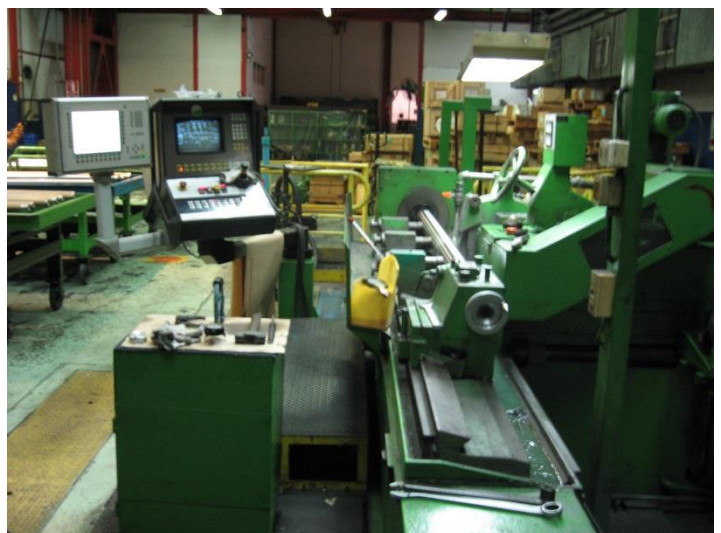
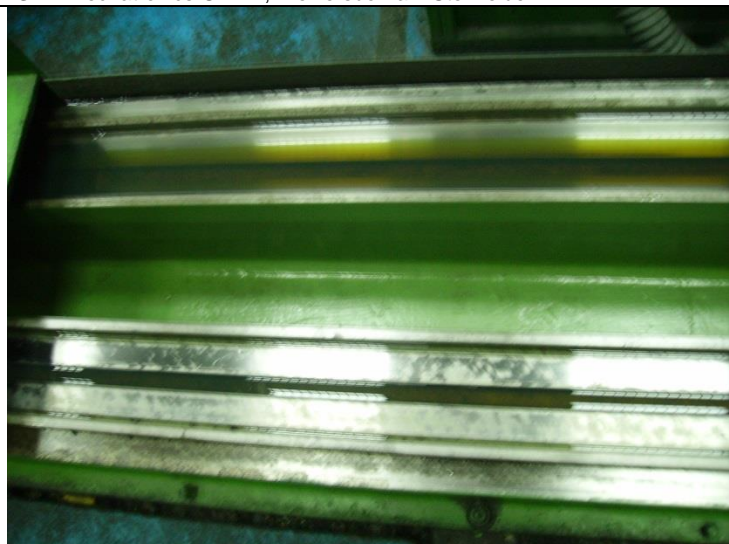
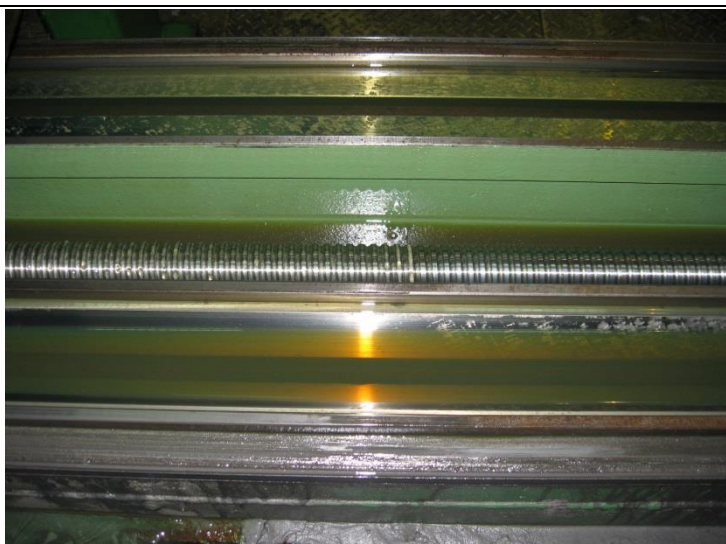
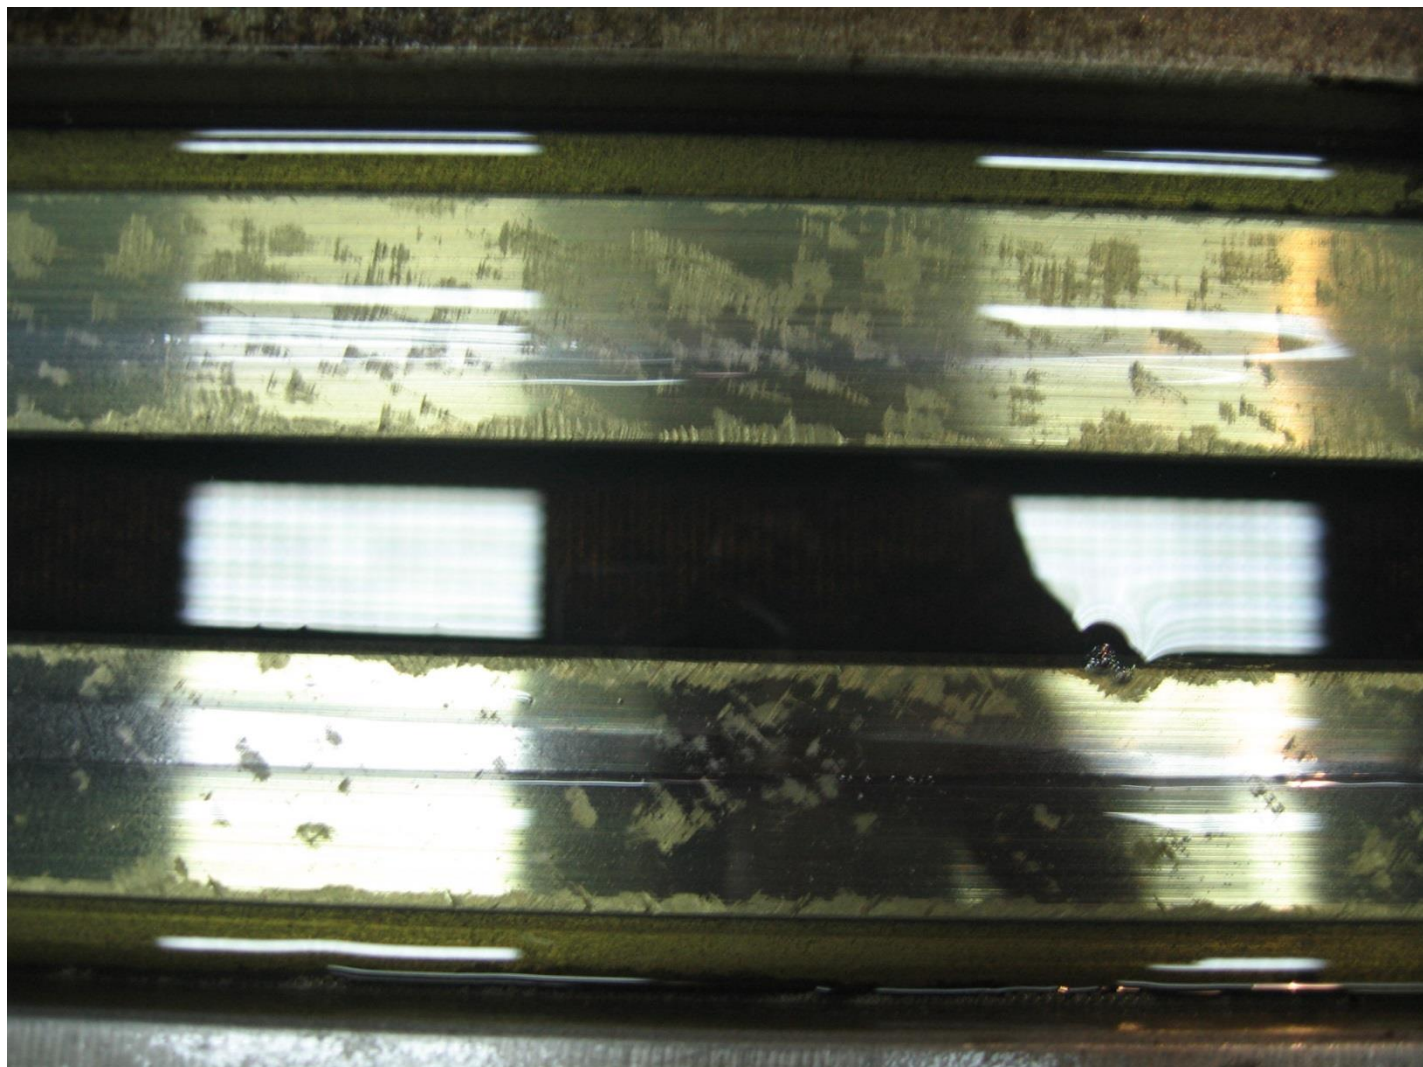
#### Condition before job :

Posco Thainox planned to refurbish 2 small Herkules table roll grinders and a big roll grinder for grinding the backup rolls. The original OEM grinder control system was still running but the mechanical condition especially the machine bed alignment was insufficient.

- Leveling and alignment of Z-axis guide-ways.
- Renovation of Z and X-axis guide-ways by scraping.
- Mechanical inspection and preventive maintenance of all major components.
- Checking and repair the head stock to remove the vibration if it is necessary and the time is sufficient.

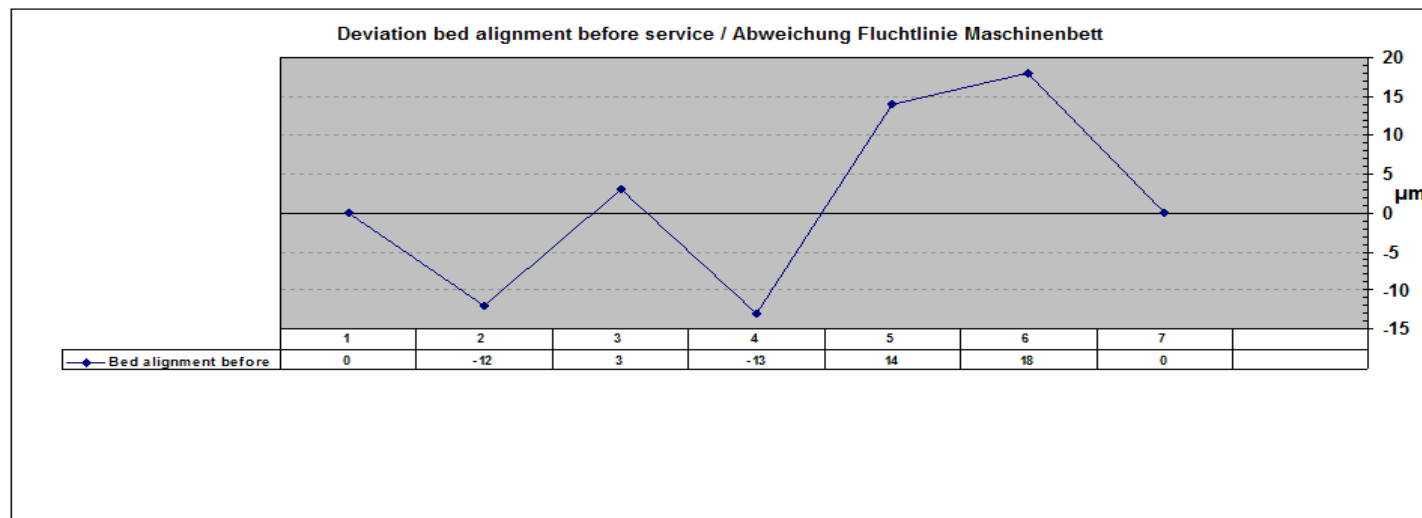
### ZRG3:

The alignment deviation is 10 micron in plus and 13 micron in minus direction.

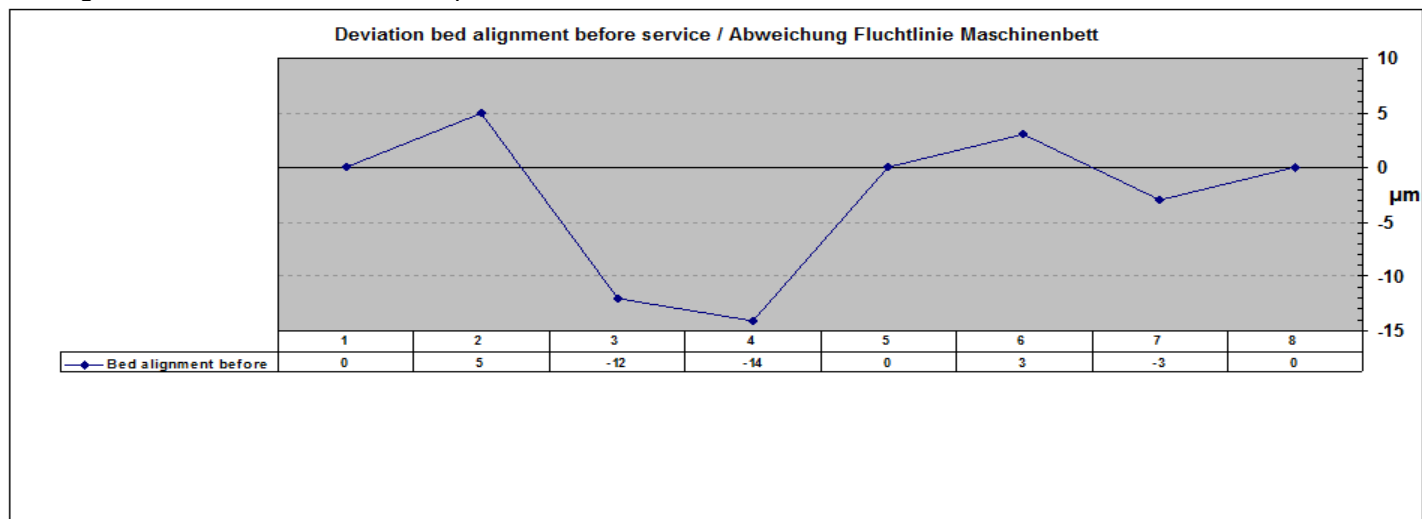
### ZRG4:

The alignment deviation is 5 micron in plus and 14 micron in minus direction.

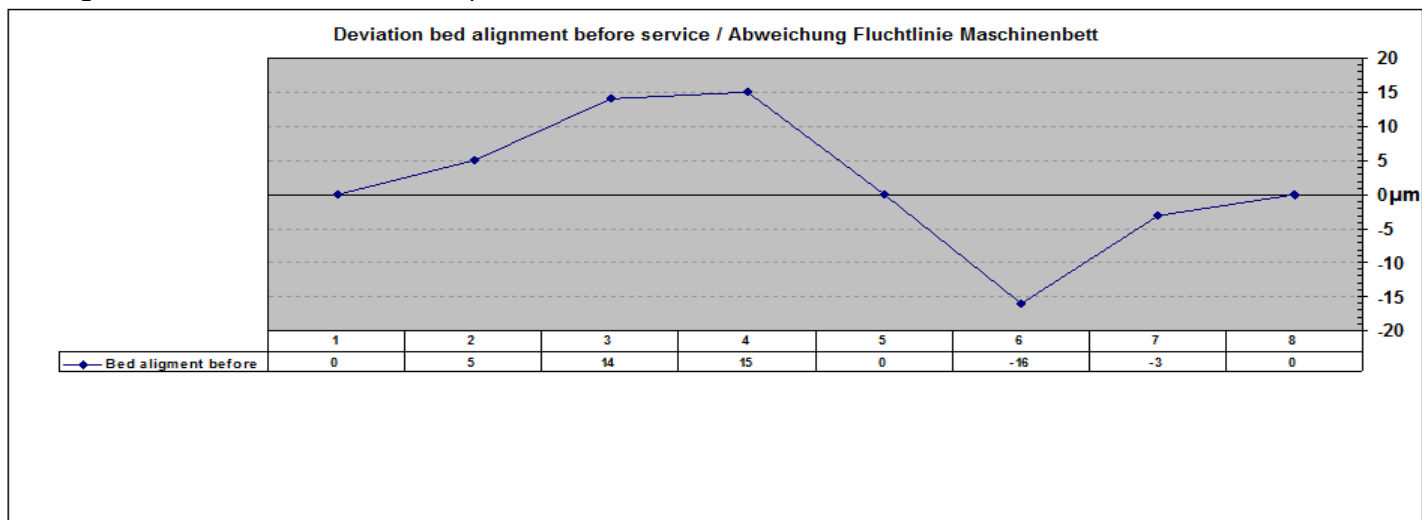
### SRG1:

The alignment deviation is 15 micron in plus and 16 micron in minus direction.

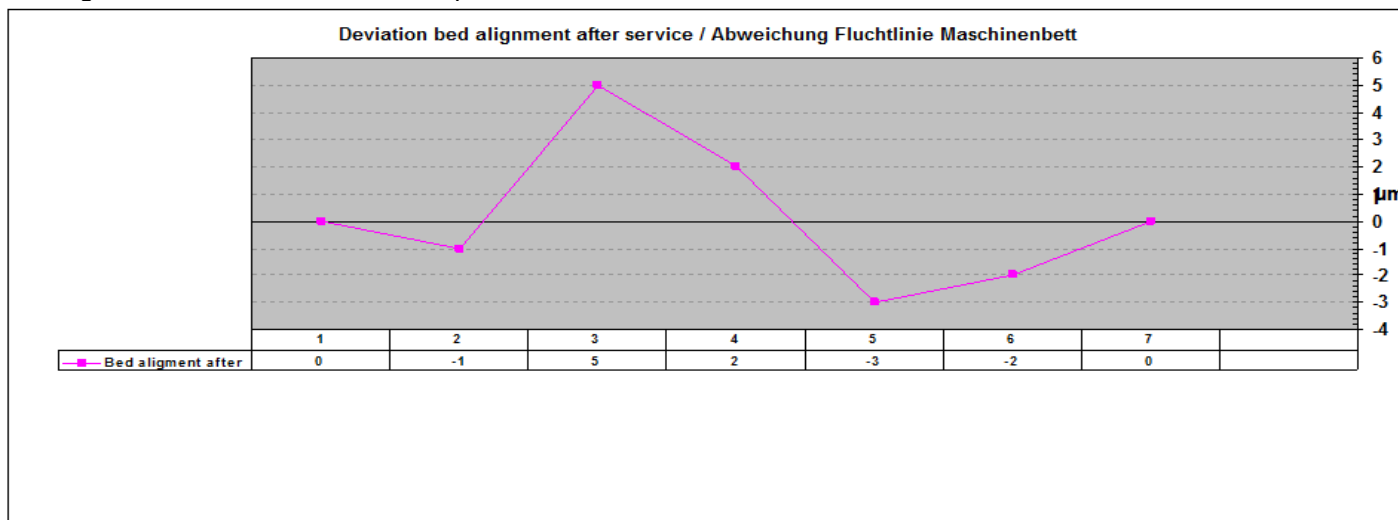
### ZRG3:

The alignment deviation is 5 micron in plus and 3 micron in minus direction.

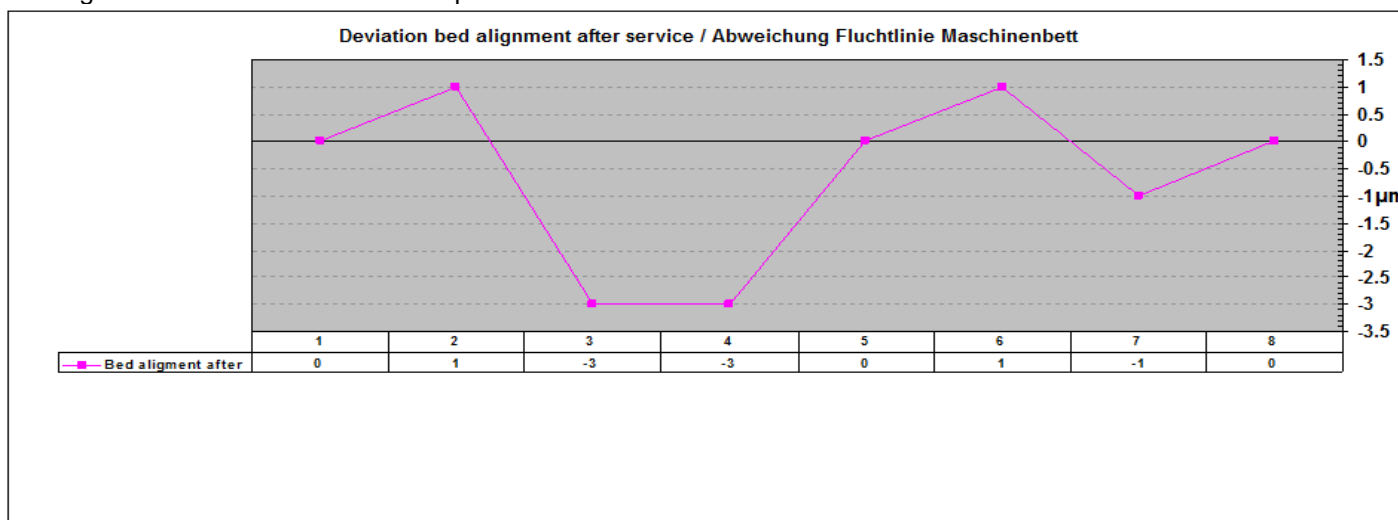
### ZRG4:

The alignment deviation is 1 micron in plus and 3 micron in minus direction.

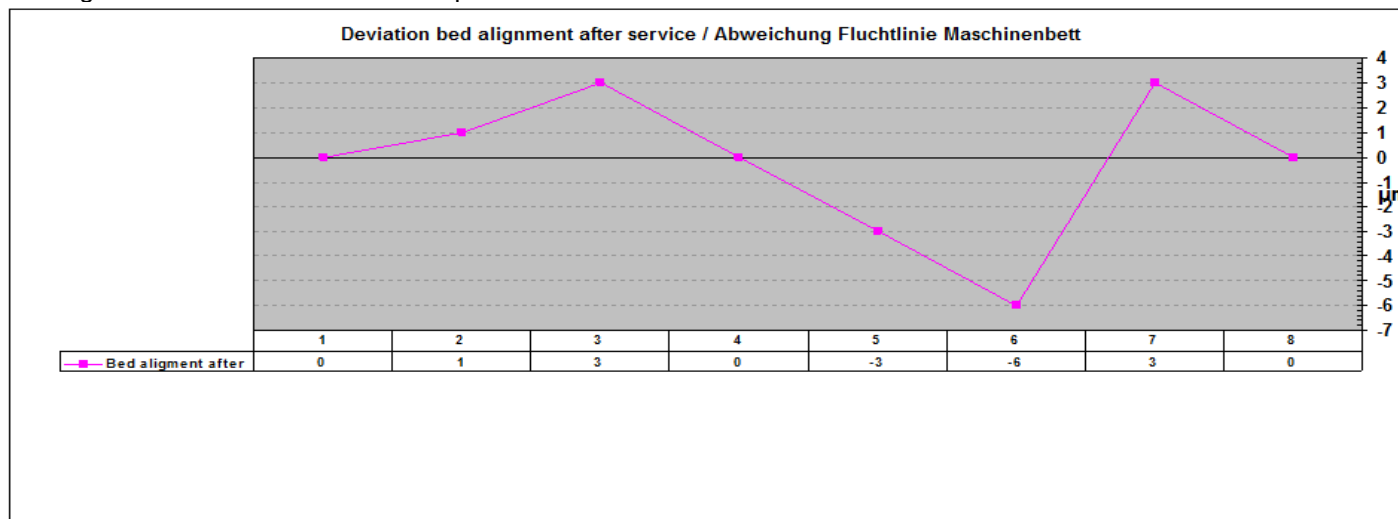
### SRG1:

The alignment deviation is 3 micron in plus and 6 micron in minus direction.
